New Kent County, Virginia Shoreline Inventory Report Methods and Guidelines

**Comprehensive Coastal Inventory Program
Center for Coastal Resources Management
Virginia Institute of Marine Science, College of William and Mary
Gloucester Point, Virginia
October, 2008**

Special report in Applied Marine Science and Ocean Engineering No. 406 of the Virginia Institute of Marine Science

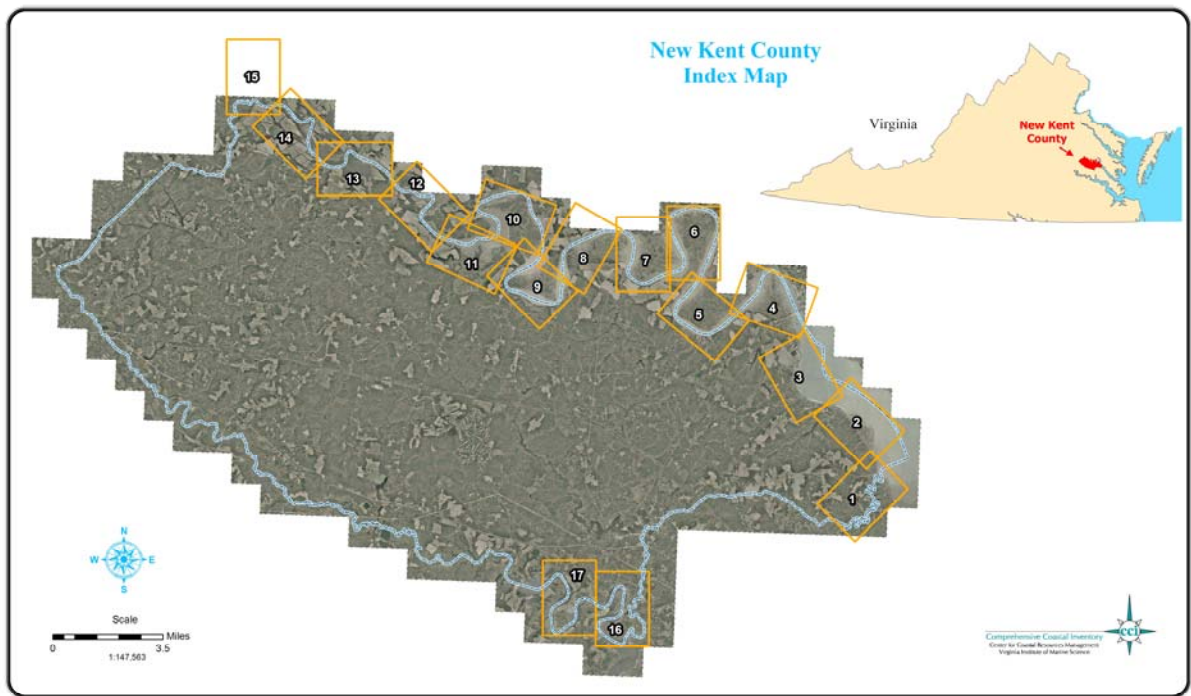
Figure 2. Map index for New Kent County

Once you determine which plate you want, the scroll down menu on the left has links to the four part series for each plate (Figure 3). At the top of the scroll bar Riparian Land Use (plate a) is first. You can scroll down to see links to maps illustrating Bank Conditions (plate b), Shoreline Features (plate c), and Natural Buffers (plate d). The content and details of the four part plate series was described in detail in Chapter 2. The actual map will come up when you click on the plate number. For example, Figure 4 is the riparian land use map for plate 14. Figure 5 is the map illustrating bank conditions for plate 14. Figure 6 shows all the shoreline features for that same area, and Figure 7 the natural buffers associated with that section.
